Special Issue "Research & Practice", 15 June 2021, pp. 12-25

Assessment of Natural Hazard in the Himalayas: A Case Study of the Seti River Flash Flood 2012

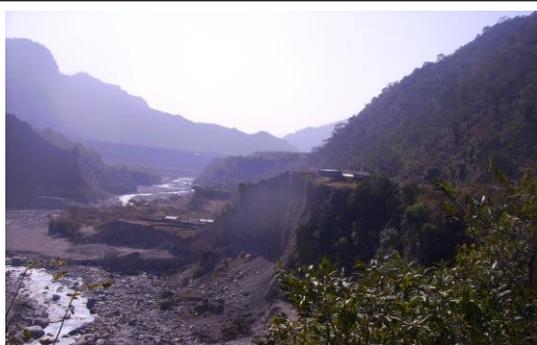
[Photo 1]. Upper part of Pokhara valley, near Talunge

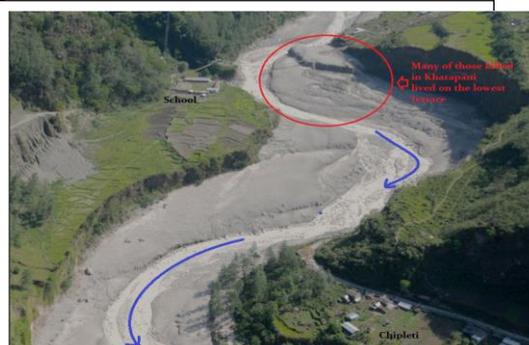
[Photo 2]. Devastated Kharapani (Tatopani) Area

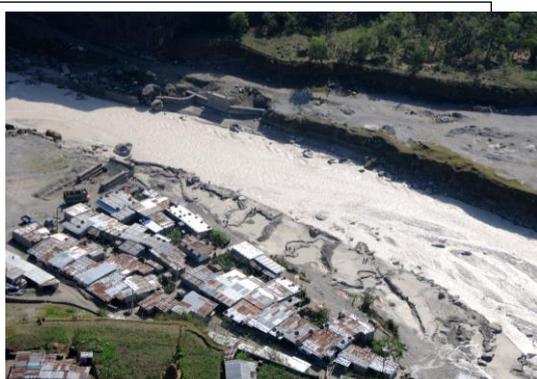
[Photo 3]: Highly vulnerable houses (Masina Bagar of Hemja) within 50m Seti River course.

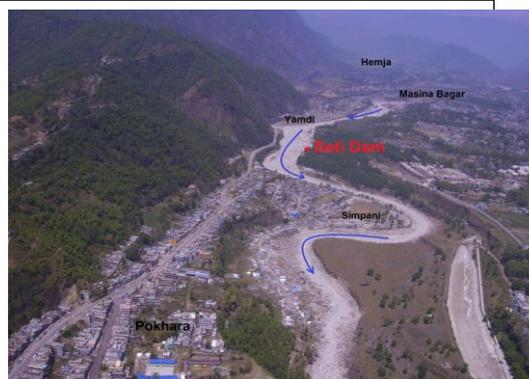
[Photo 4]: Seti Dam and vulnerable settlement within 50m of Seti River course.

The overall affected area covers household settlements from the Seti River courses, particularly from Ramghat of Pokhara Metropolitan City to Jimirebari of Machhapuche Rural Municipality. The Seti River Flood Disaster Area (SRFDA) covers Machhapuchre, Sardikhola, Ghachowk, Lahachowk, Puranchaur, Lamachaur, Hemja and some areas of Pokhara Metropolitan City. According to the population census 2011, the total population of SRFDA is 289358 residing within 76,556 households. Out of the total households, only 810 (1.06%) households fall within the 50-meter margin from the Seti River. Out of total marginal households, only 163 (20%) households were purposively selected for finding characteristic features of population and settlement. For simplicity, the marginal area from Ramghat to Jimirebari were designated as Seti River Corridor (SRC) and divided into three sections viz. Upper Seti, Middle Seti, and Lower Seti. The area above Kharapani is named as Upper Seti, [Photo:1&2] Kaskeri to Kharapani as Middle Seti [Photo:3] and Ramghat to Kaskeri as Lower Seti, [Photo:4] respectively.

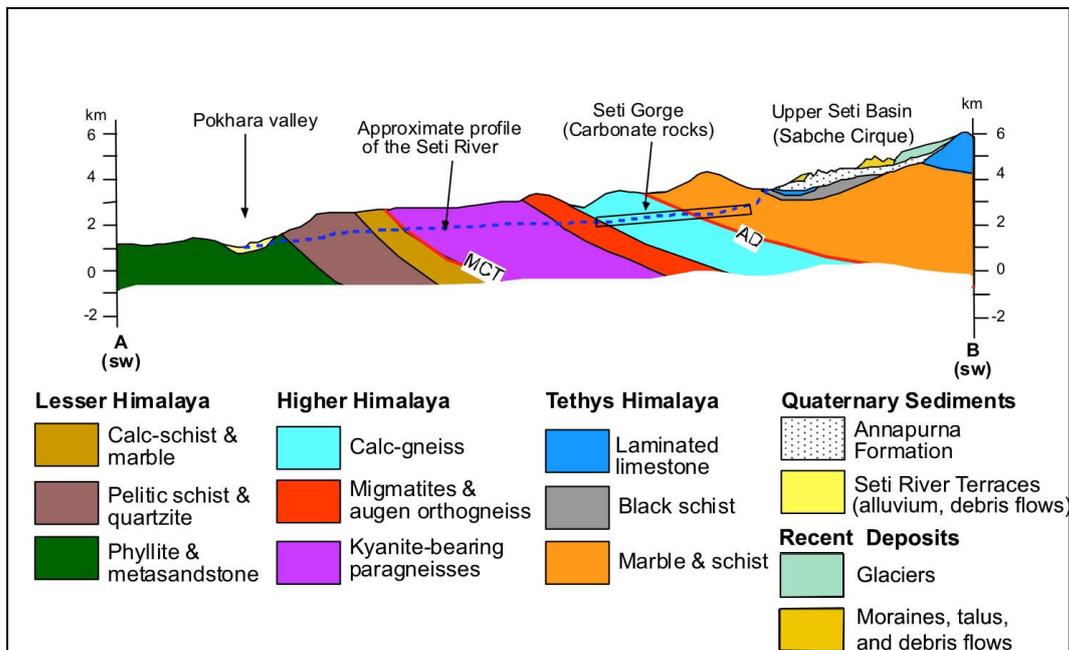
Figure 3
Simplified, Schematic Geological Cross-Section across the Pokhara Valley

According to the regional geological map and cross-section of the Seti River Basin that cover the area north of Pokhara (Kargelet al., 2013), the lithology of the area was separated into several mappable units based on distinctions of lithology, presence or absence of fossils, sediment consolidation, and the position within the overall rock sequence. The lithological boundaries observed along the accessible routes were extended to the inaccessible areas based on the orientation of the beds and foliation (strike and dip). The bedrock of the area can be divided into three tectonic units, i.e., the Lesser Himalaya, Higher Himalaya, and the Tethys Himalaya separated by major regional faults, namely, the Main Central Thrust (MCT) and Annapurna Detachment (AD). The unconsolidated materials are much younger and include the Annapurna formation (calcareous silts, sands and gravels) and recent glaciers, moraines, debris flows and alluvial gravels. As we have described below, the 2012 disaster has a strong involvement from the deep Seti River gorge and the high, steep peaks of the Annapurna Range; these are erosional features developed in the rocks of the Tethys Himalaya and Higher Himalaya.

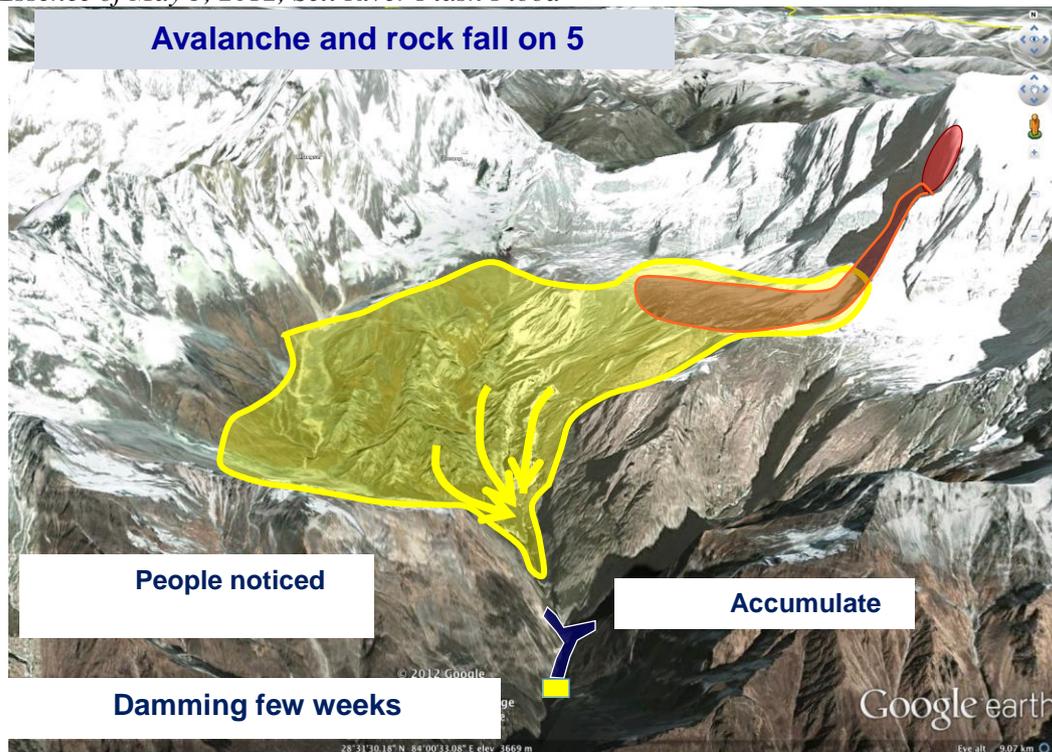
Photo 5

Essence of May 5, 2012, Seti River Flash Flood

have been below the point where the major tributaries within the Sabche Cirque join but above the upstream villages where the diminished (almost zero) flow was observed. This constrains the point of blockage to a short segment of the Seti River. Had the blockage been above the point where the two major tributaries (the north branch and west branch) join in the gorge area, perhaps half (more or less) of the water would have been blocked but much flow would have continued. This first clue tends to rule out the glacier ice and the Annapurna formation as hosts of the reservoir, but it allows the gorge and also could allow any karstic cavernous spaces connected to the gorge that could have been filled due to damming of the gorge [Photo:5].

When the Seti River was blocked, a trickle continued but changed its color from the usual white caused by abundant suspended rock flour. (“Seti” means “white,” so it is the White River) Hence, water draining from the glaciers and the Annapurna formation was blocked, leaving only small amounts of water runoff from points below the glaciers and the Annapurna formation. This again points to a blockage in the gorge area below the Annapurna formation and below where the two major tributaries join.

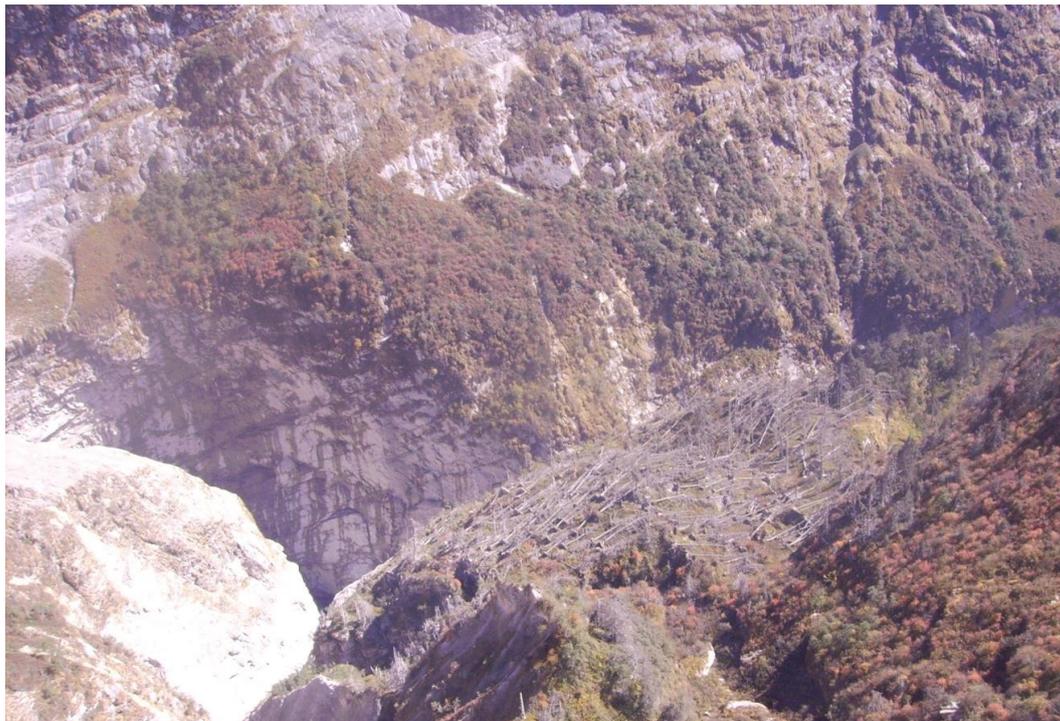
Photo 6

Flattened forest blown down by the avalanche winds. Gorge starts from Upper Seti basin nearly 3000m height from asl

Our observations have indicated that the gorge volume is far greater than we had initially believed, and so it could have contained enough water and sediment volume to have explained the slurry flood disaster. The gorge is both wider in some sections and far deeper (exceeding 500 m) than we had suspected at first [Photo: 6]. The gorge geometry

is such that a contained volume of more than 107 m³ is possible, i.e., enough to explain the 2012 outburst flood volume. Furthermore, there remains some speculation with some limited supporting observations that the gorge geometry may widen at the bottom with karst cave-like structures, which may add to the present estimations of contained volume. Consequently, our earlier assessment that the flood water volume required multiple sources is no longer a requirement. The gorge alone with or without additional water-filled karstic caverns-might be sufficient to explain the flood volume.
